Manhole Inspection Summary

Manhole # S25MM_031MH

Location Address: **940 WHITELOCK ST**

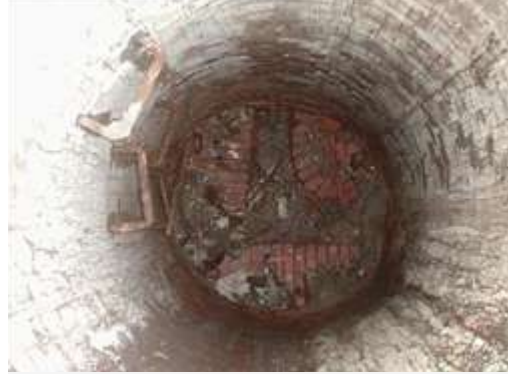
Top View

Corroded and missing steps. Bench and Channel debris.

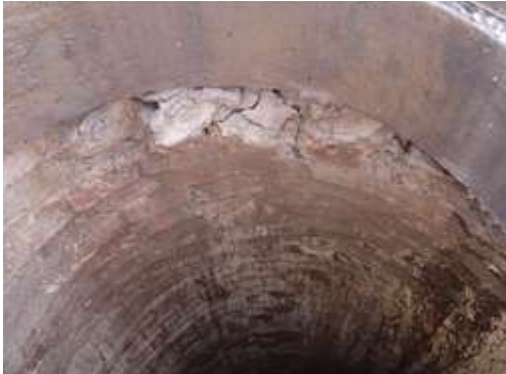
Defect

Frame leaks. Adjustment deterioration and infiltration. Corbel and Barrel infiltration - other side.

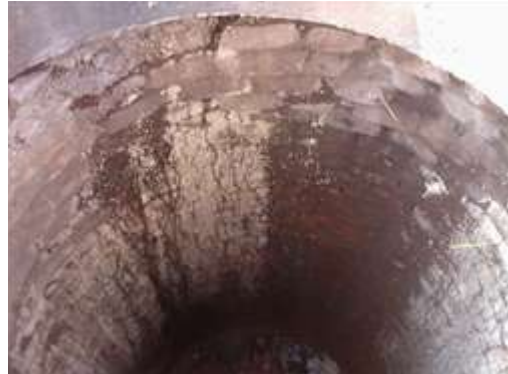
Defect

Frame leaks. Adjustment deterioration and infiltration. Corbel and Barrel infiltration.

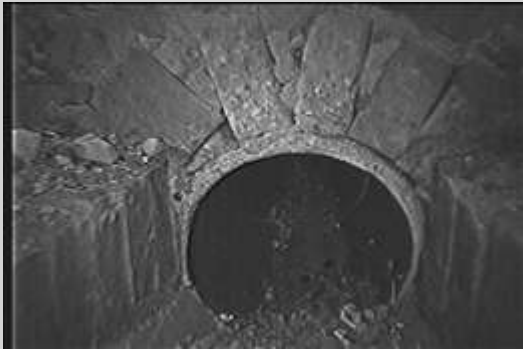
8 in. Circular Gravity Sewer
Pipe Out @ 12 O'Clock

Deposits: ☐ None ☒ **Mud** ☐ Sludge ☒ **Debris** ☐ Grease

Silt Depth: **0.5** (in.) Deposits Extent: **Light**

Infiltration: **Evidence** Pipe Seal Cond: **Cracked**

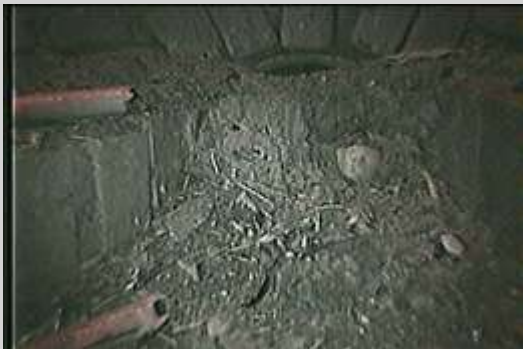
Pipe Out @ 3 O'Clock

Deposits: ☐ None ☒ **Mud** ☐ Sludge ☒ **Debris** ☐ Grease

Silt Depth: **7** (in.) Deposits Extent: **Light**

Infiltration: **Evidence** Pipe Seal Cond: **Unknown**

Connects To: **Stub connection / abandoned**
